# AERIAL PHOTOGRAPHIC ANALYSIS WASTE DISPOSAL, INC., SITE Santa Fe Springs, California

## Report 2 - Hazardous Waste Site Characterization, Oil Reservoir, and Associated Land Parcels

EPA Region 9

TS-PIC-9809925S  
September 1998

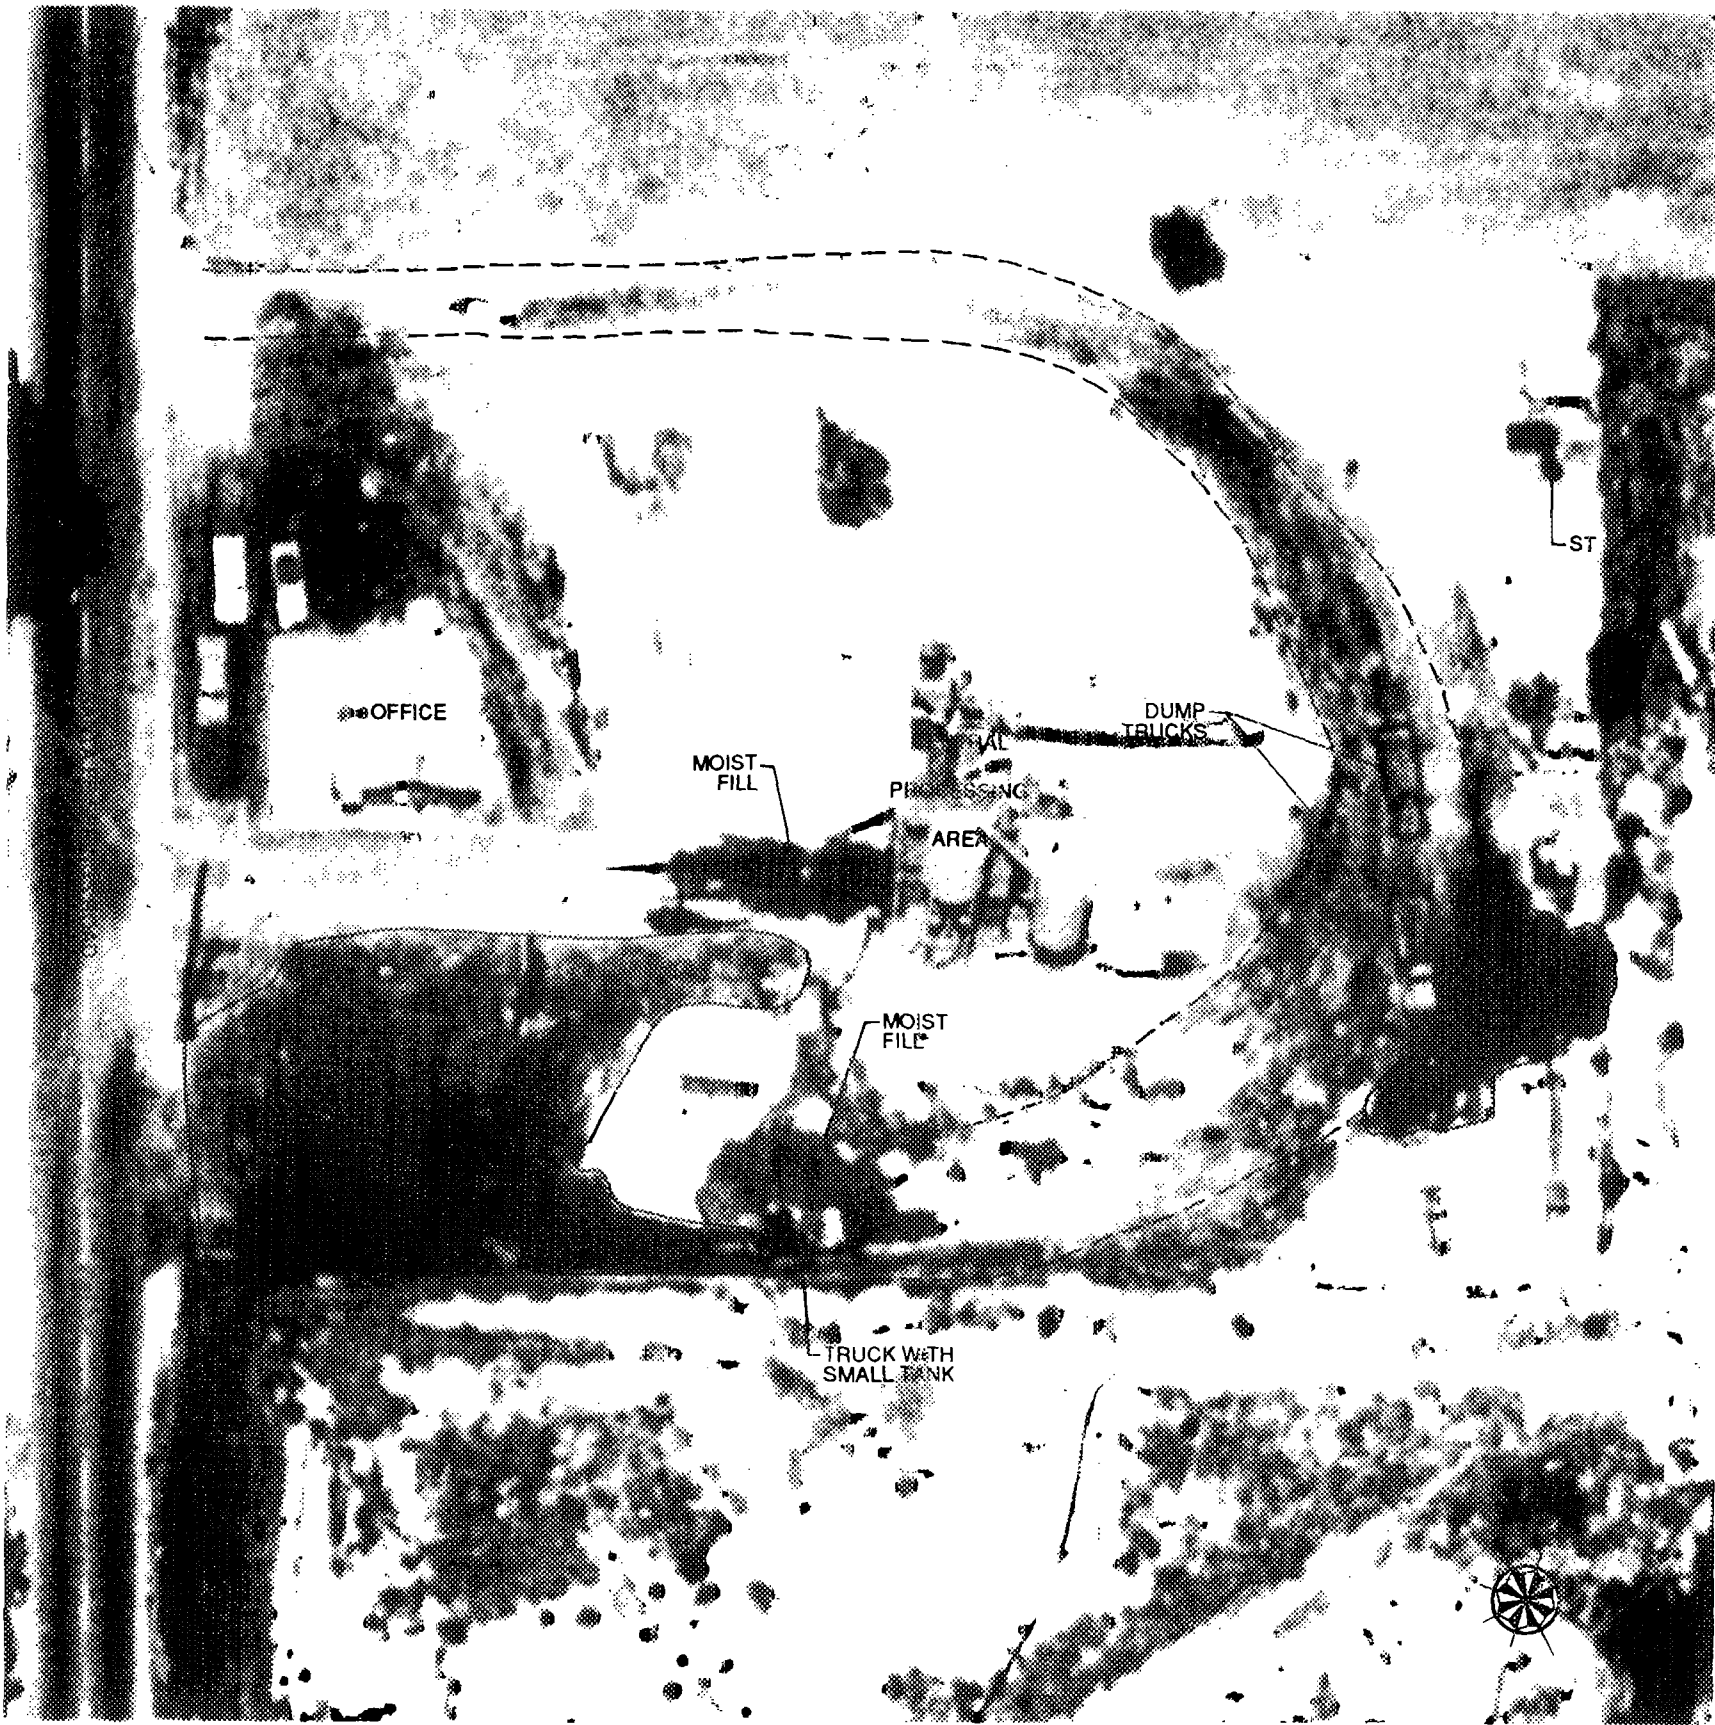
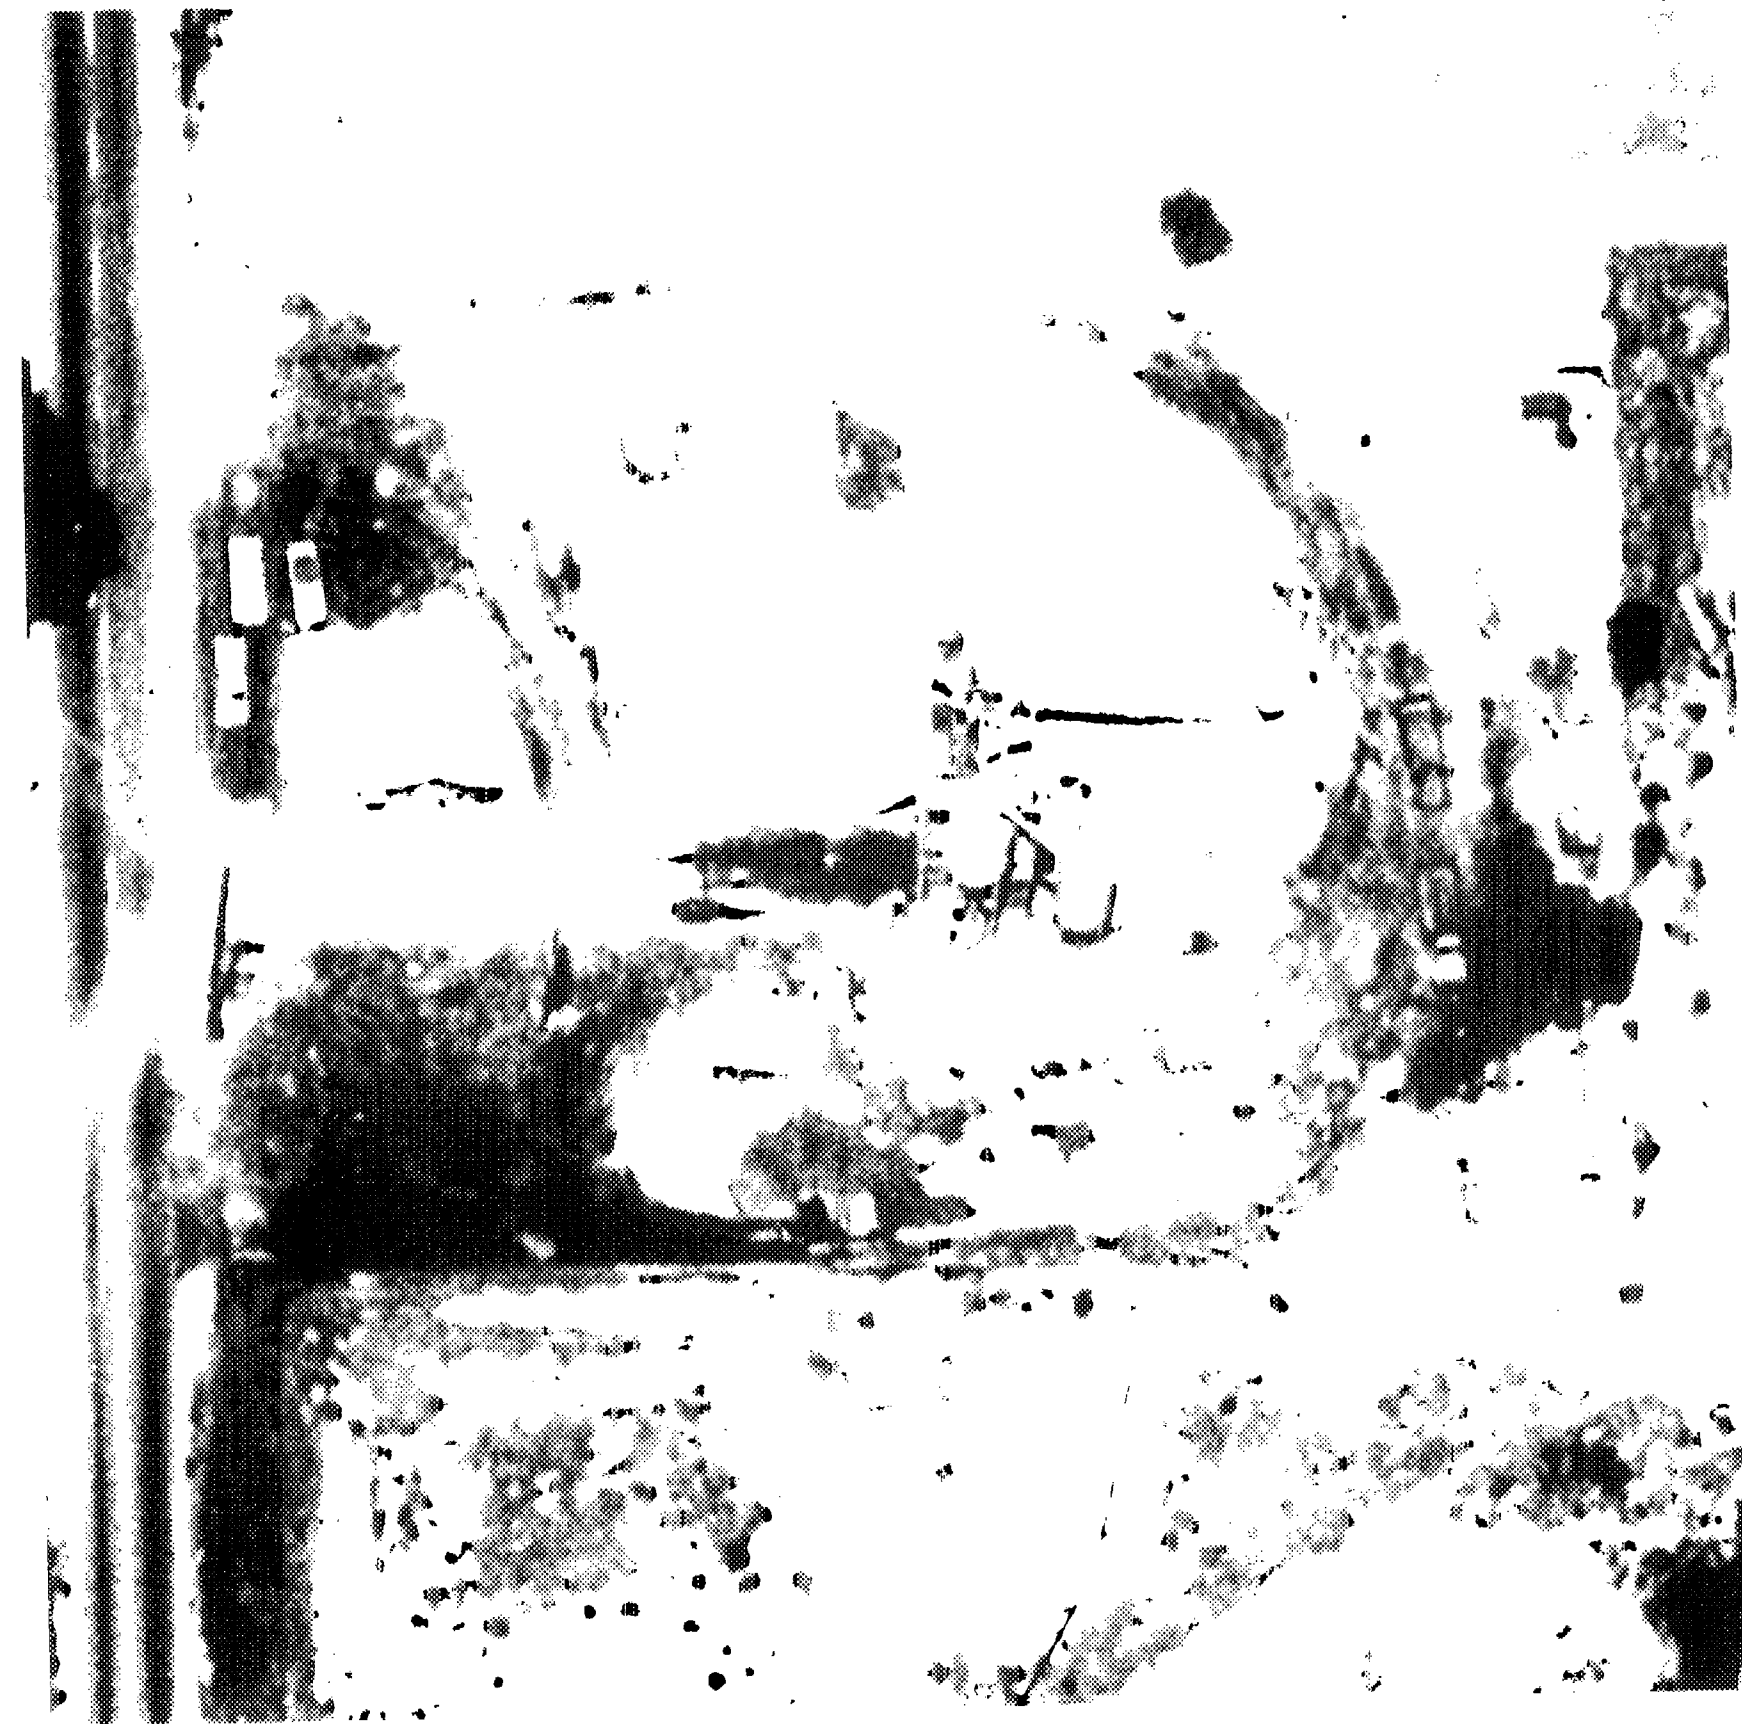
Figure 16. Waste Disposal, Inc., Land Parcel 7, June 17, 1959. Approximate scale 1:370.

Land Parcel 7\*, located in the northern corner of the site, appears to be a concrete mixing plant. A large stain is present to the southeast of the central processing area and two dump trucks are located adjacent to the stain. Staining also exists in the office parking lot and along one of the plant access roads. A large area of standing liquid and staining is present southwest of the office. A truck is present immediately southeast of this large area. Moist fill is visible near the central processing area and to the southwest. This liquid is probably associated with the concrete mixing process.
